Consolidated Edison Of New York, Inc.

SF6 Gas Management Program

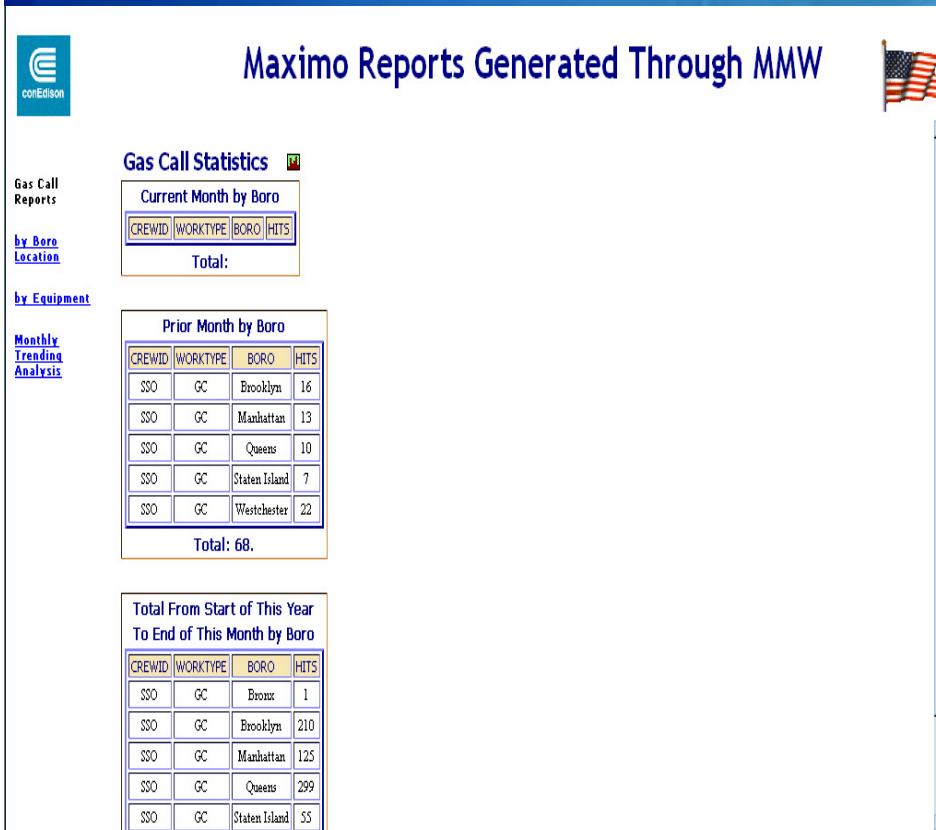
Trending The Information

- EPRI's Maintenance Management Workstation is used to trend the number of gas calls.
- This information is published on the Substation Operations web page.

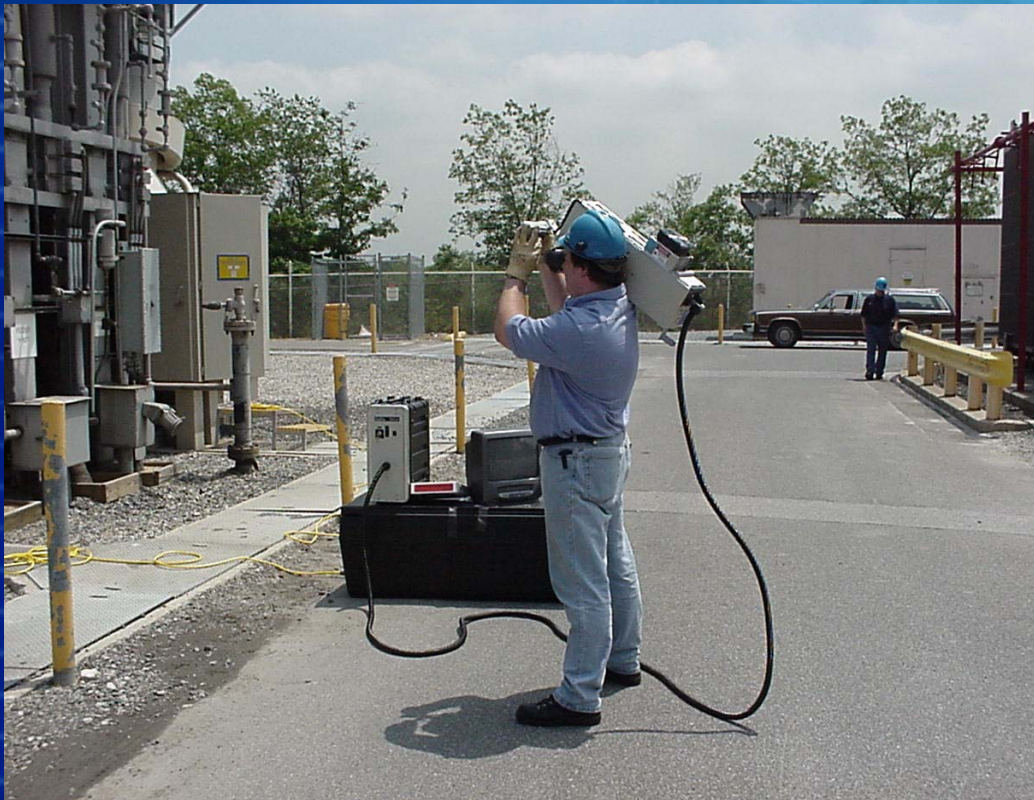
EPRI Laser Imaging System

- The laser imaging system is a back scatter laser system.
- This system provides a visible image of the gas leak. It pin points the exact location of the leak without removing the equipment from service.
